Situation Photo Log

Tuesday, May 15, 2012

Kalamazoo River / Enbridge Spill

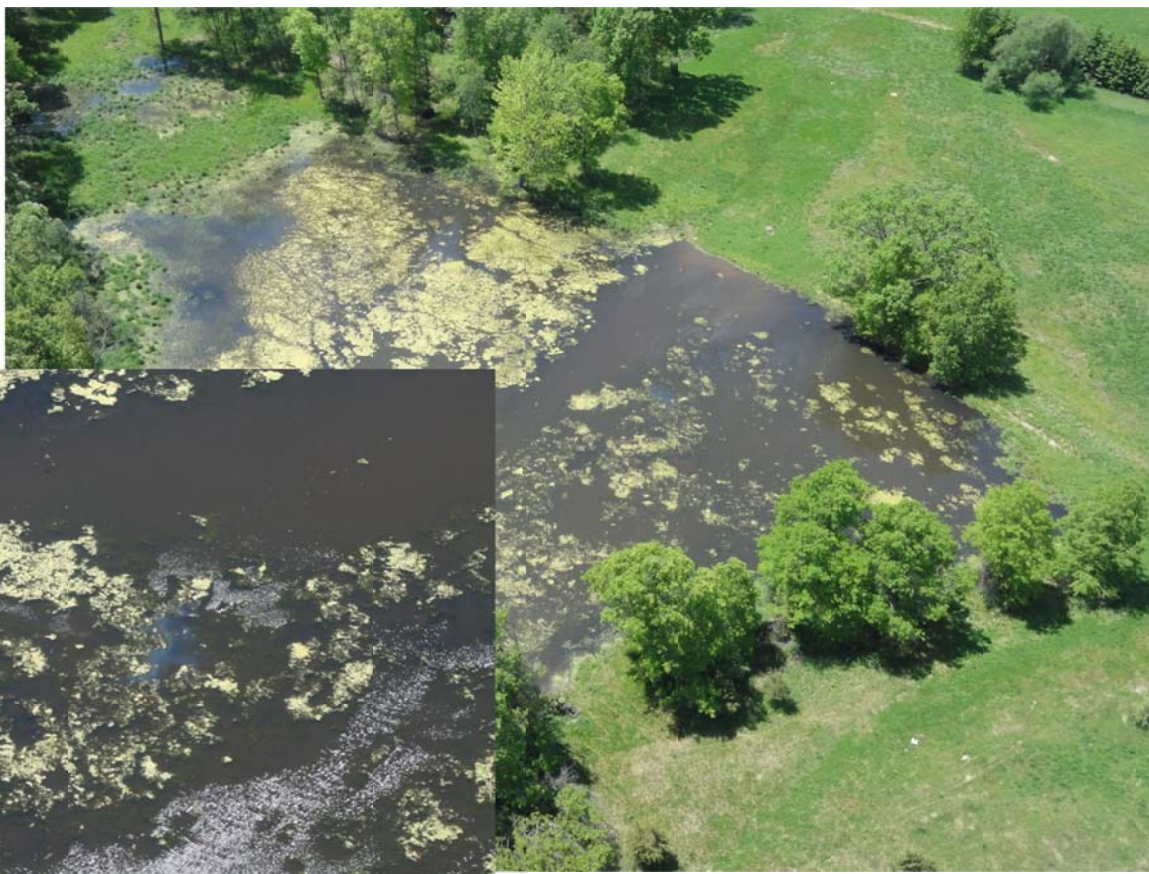
1. Source area pond, sheen observed near center of pond.

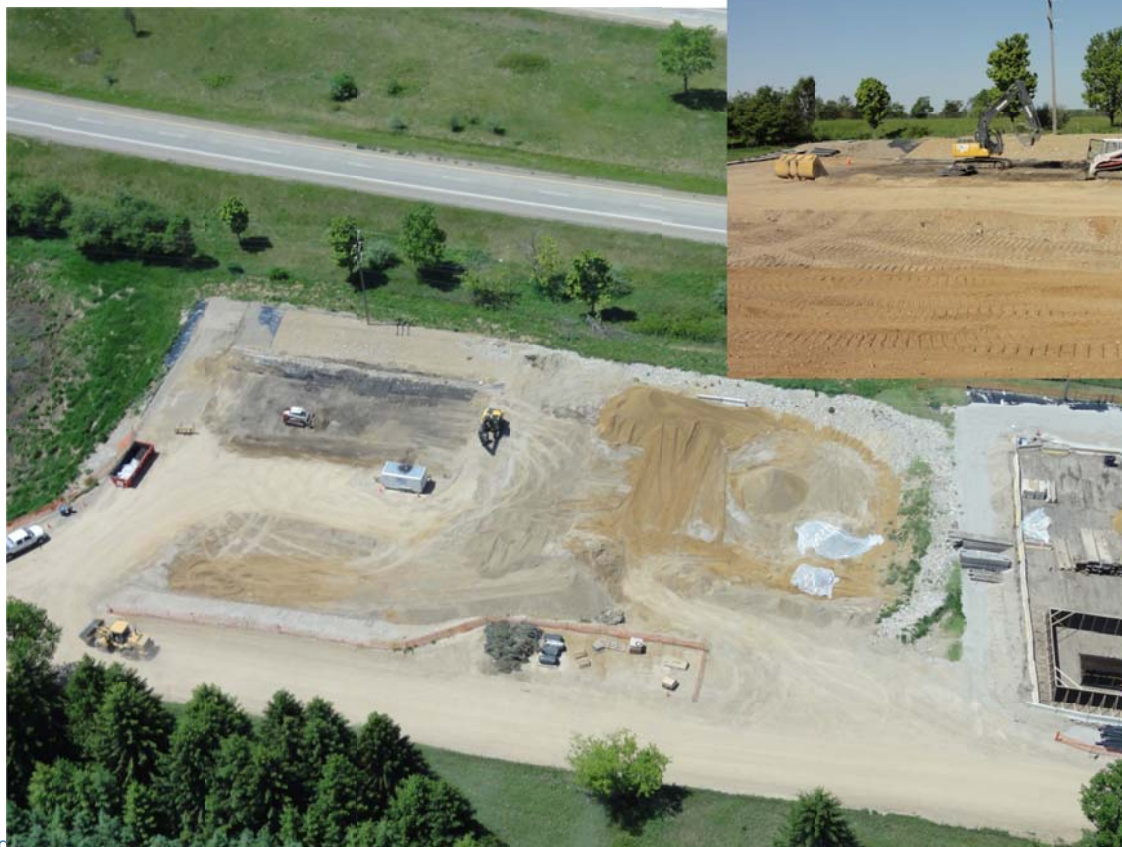
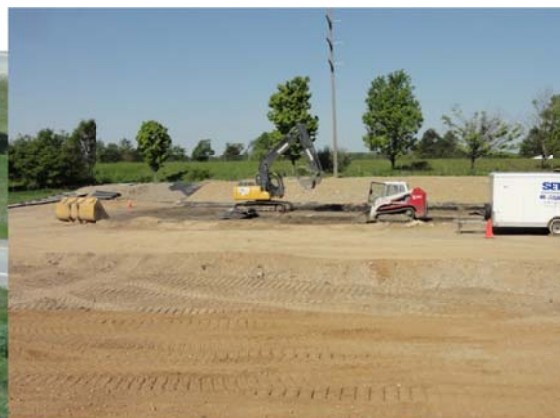
2. Frac-Tank City, footprint reduction continues.

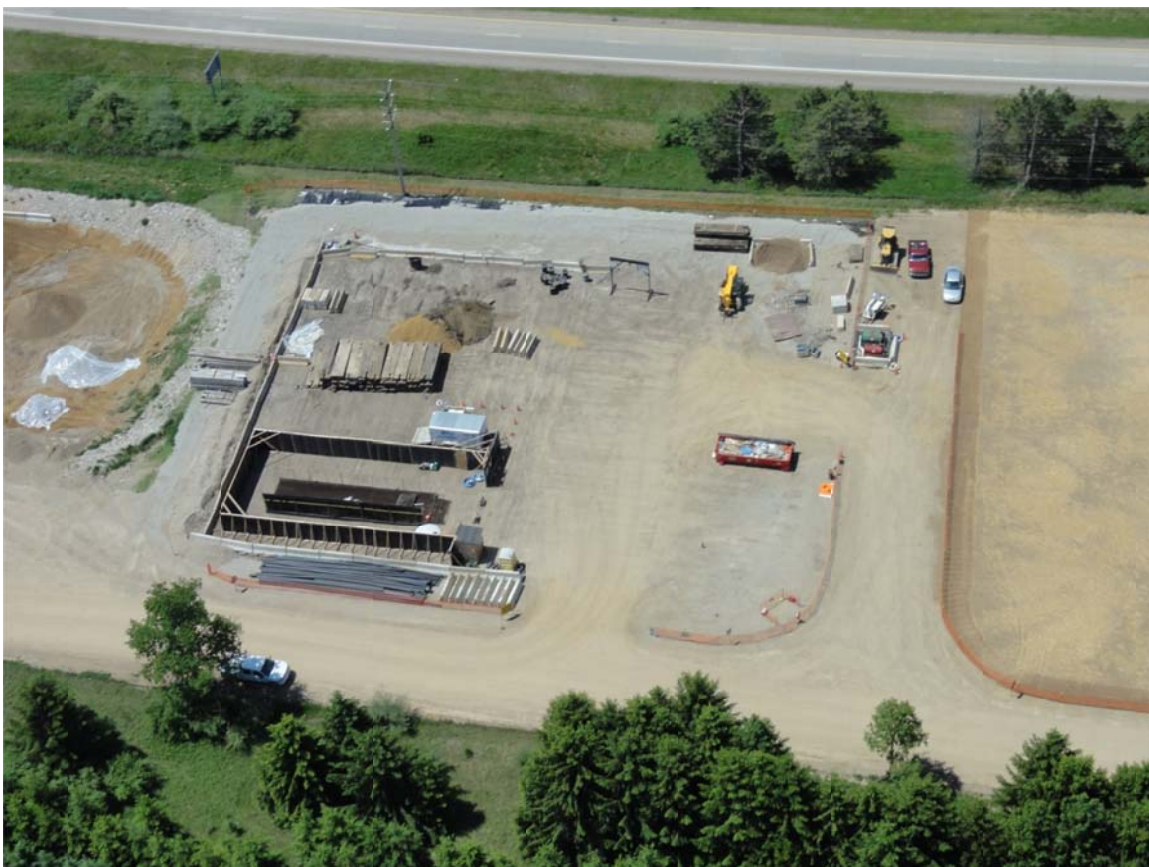
3. Frac-Tank City, new decon pad.

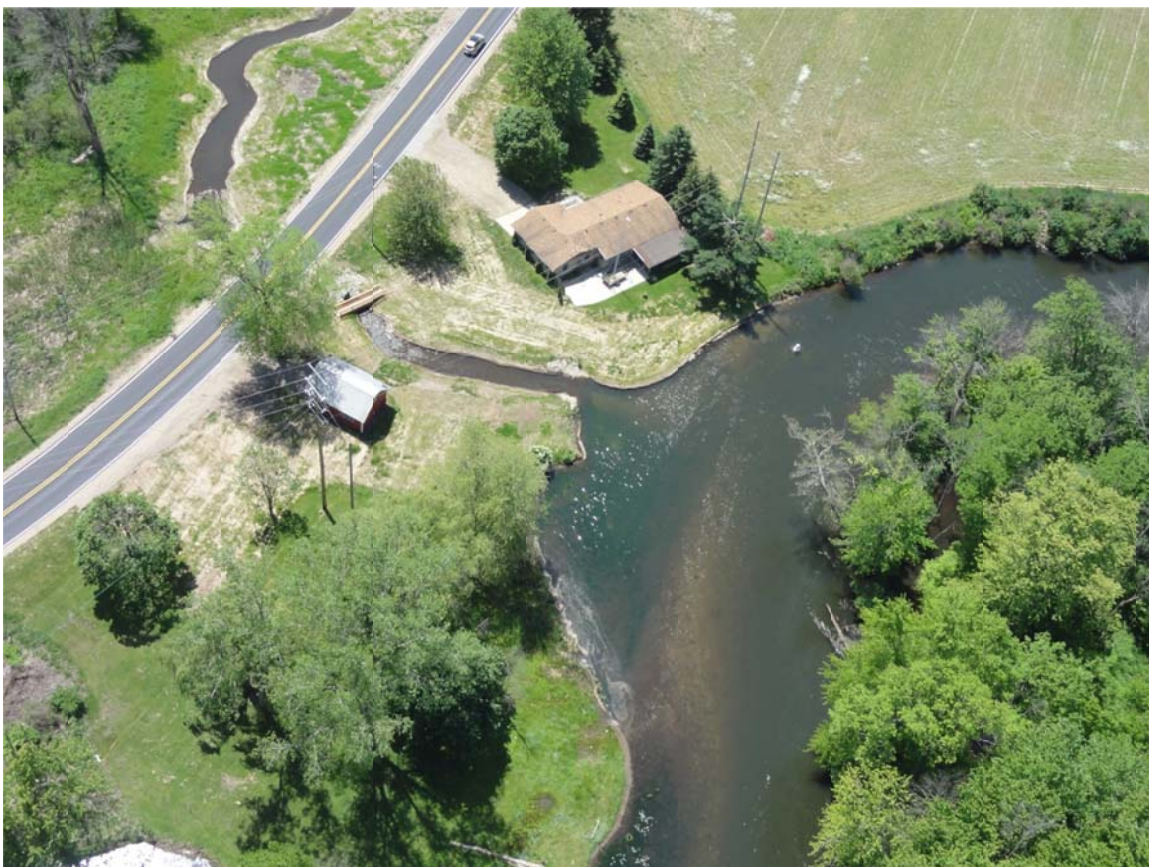
4. Confluence, no turbidity or sheen observed.

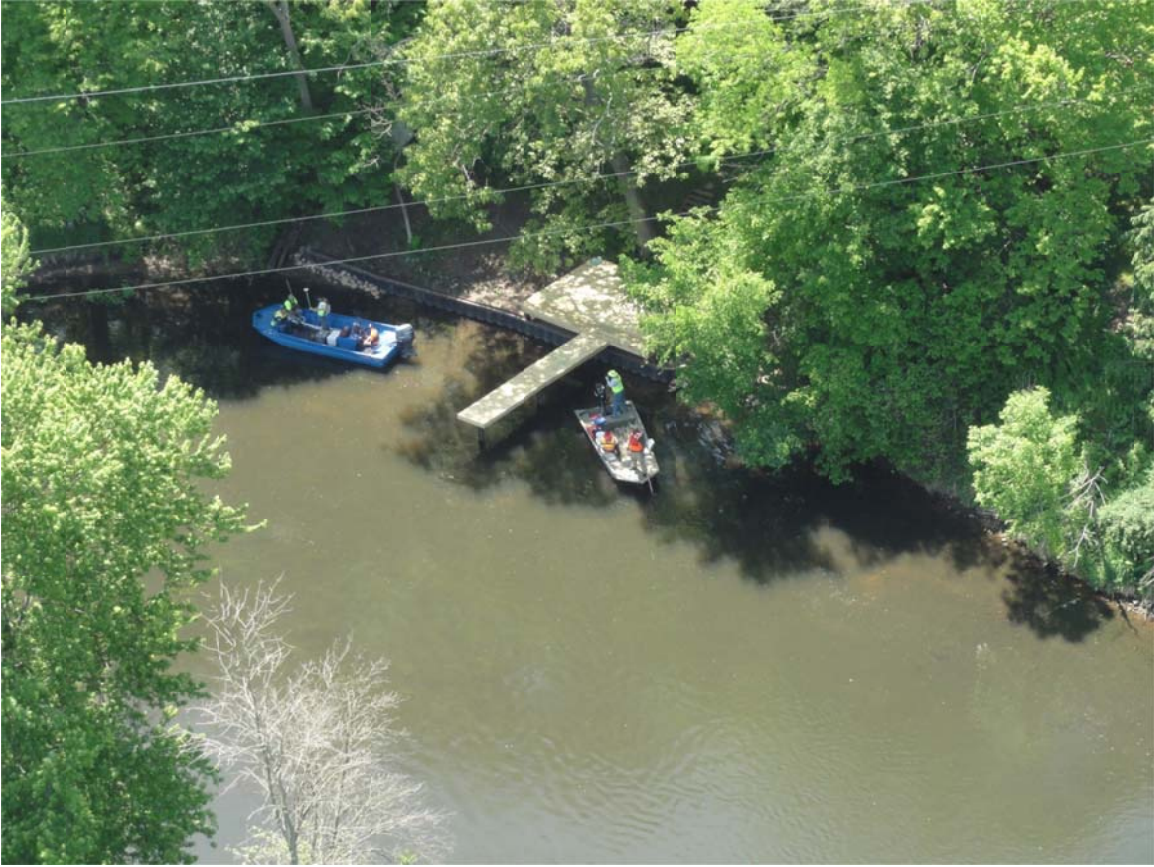
5. MP2.75 LDB, poling crew observed near new dock.

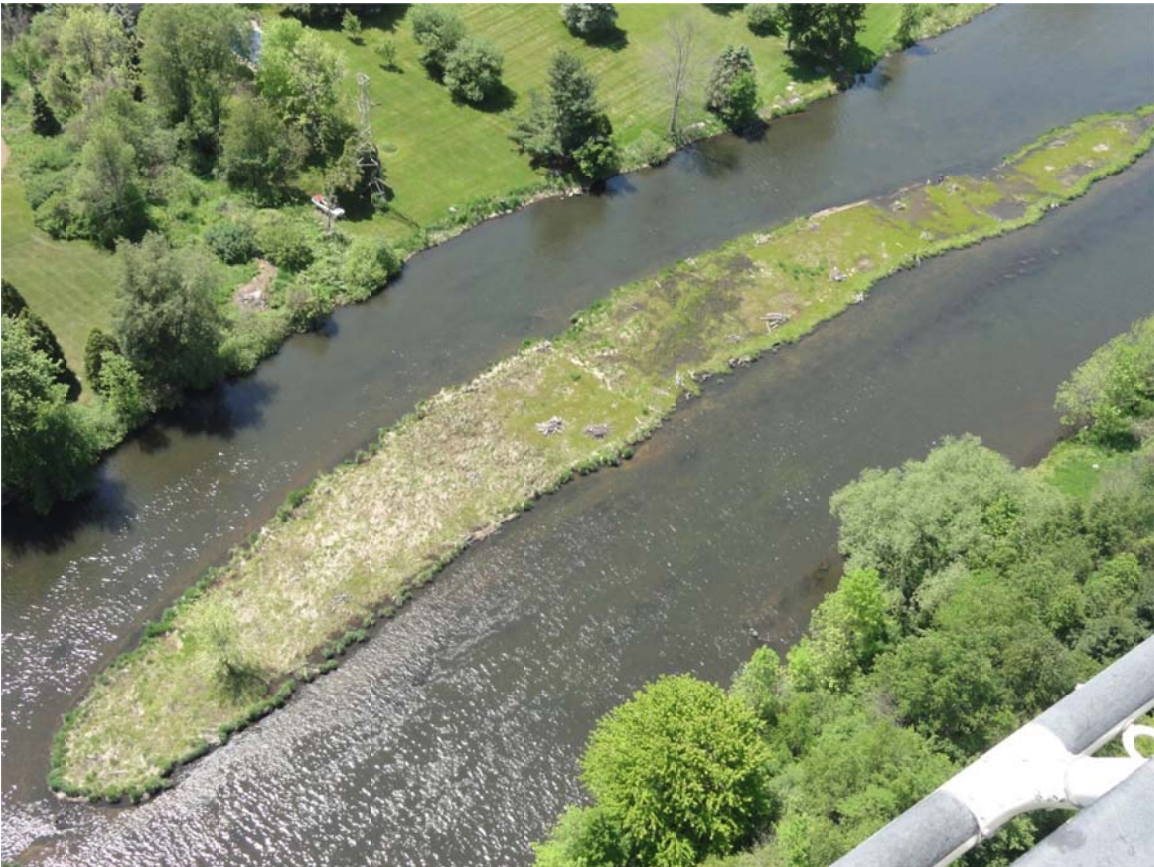
6. Island A, no sheen observed.

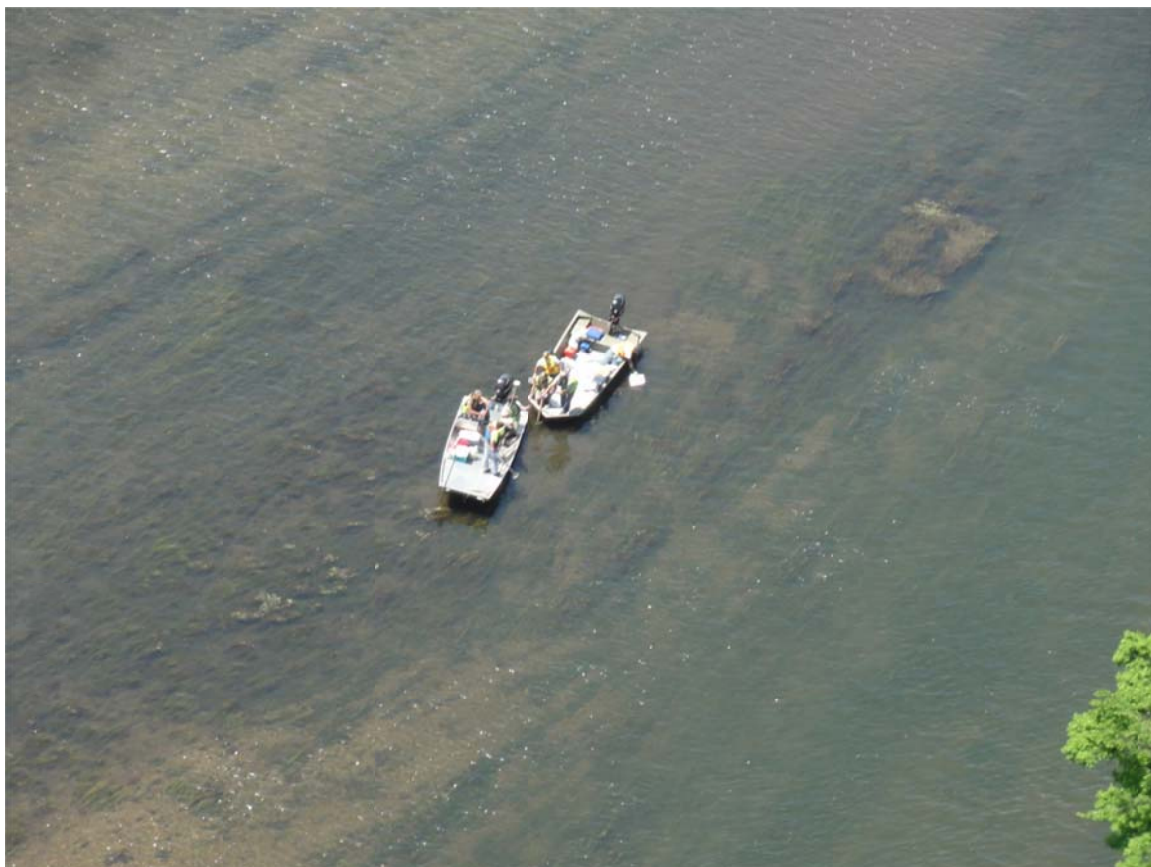
7. MP4.25, observed poling crews.

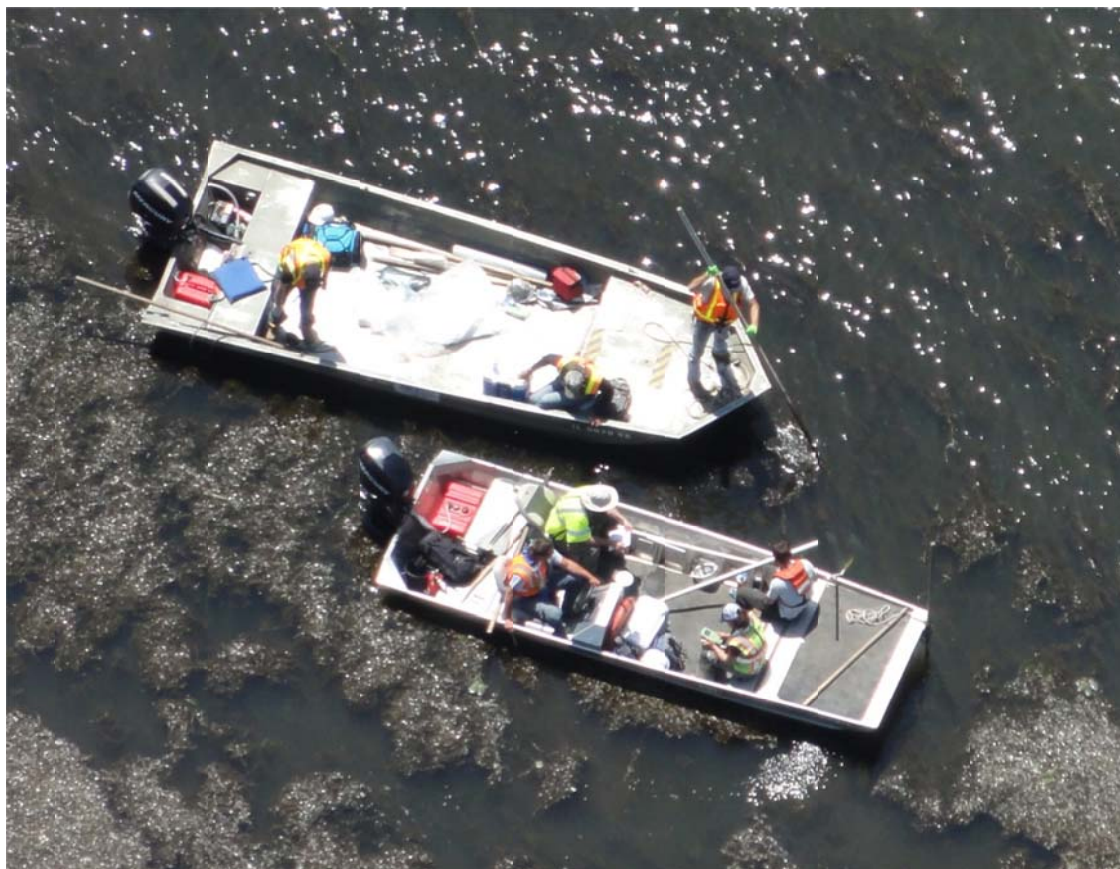
8. MP5.0, observed poling crews in river channel.

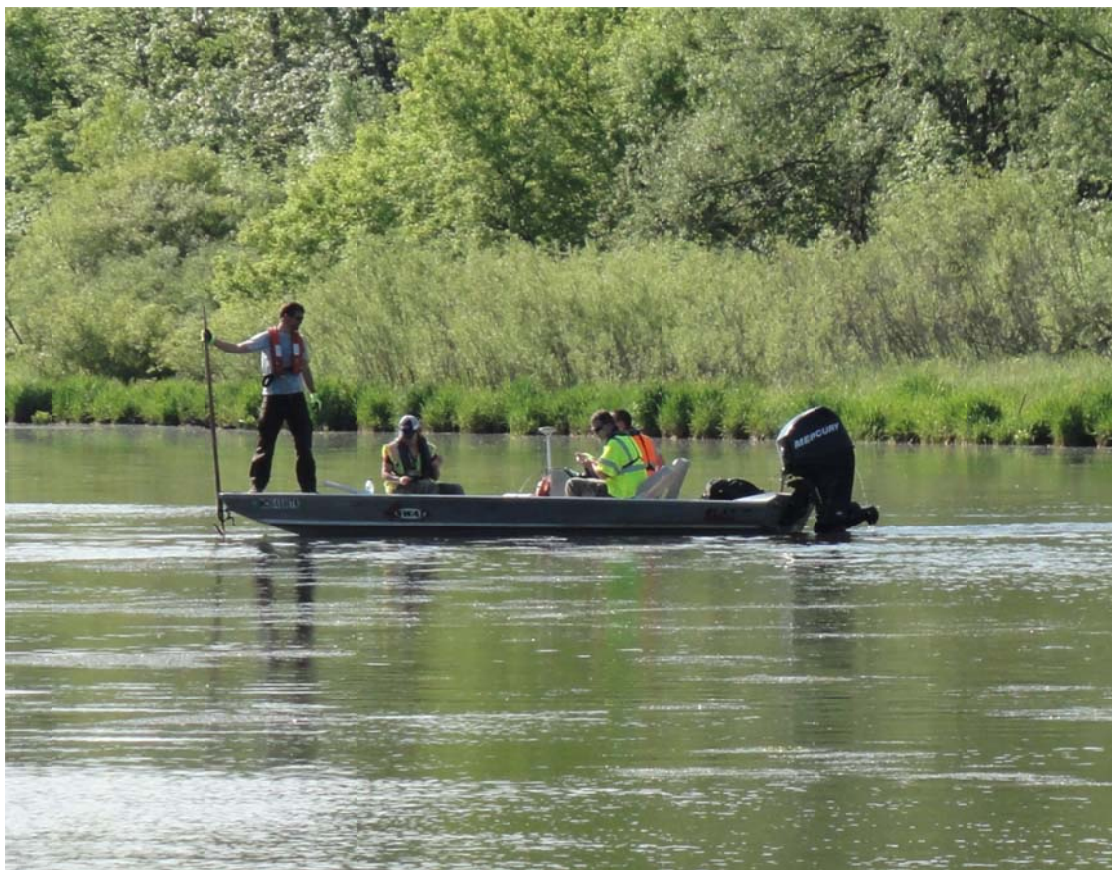
9. Poling crews just upstream from C0.4 boat launch.

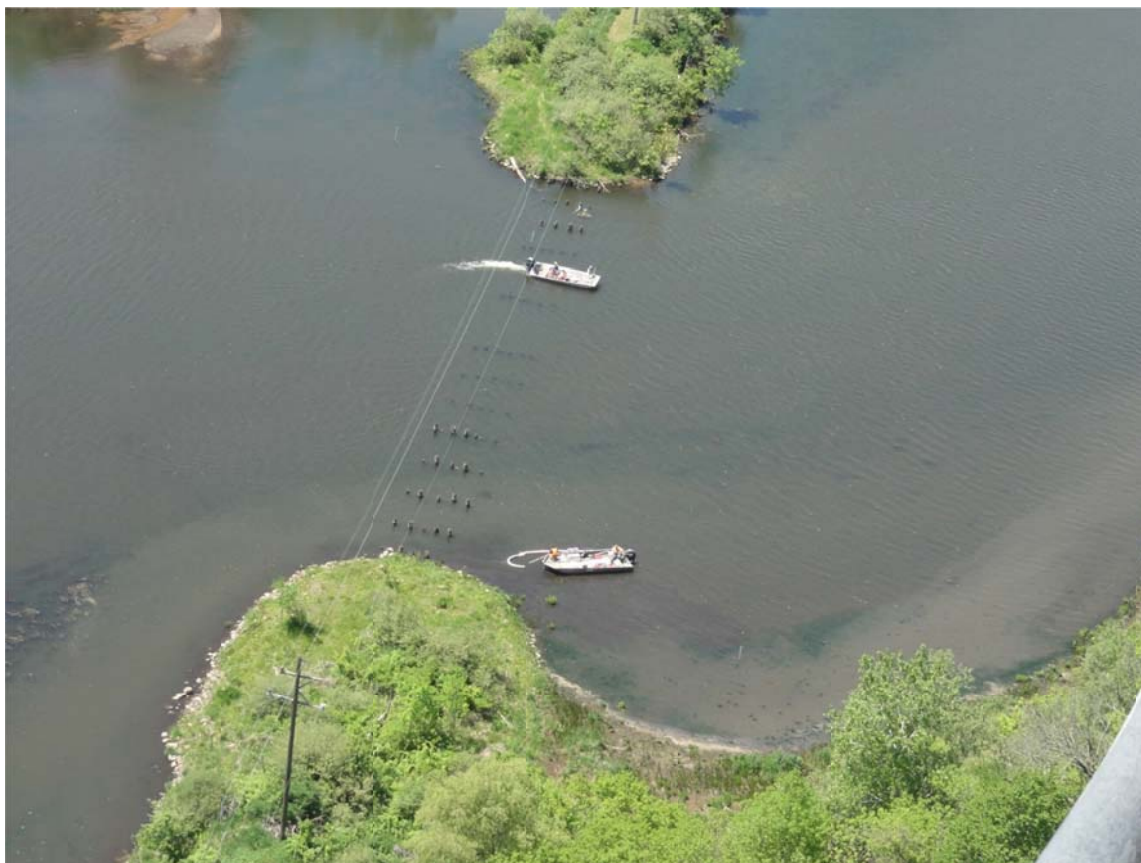
10. MP5.75, observed sweeper boats at peninsulas above Ceresco Dam.

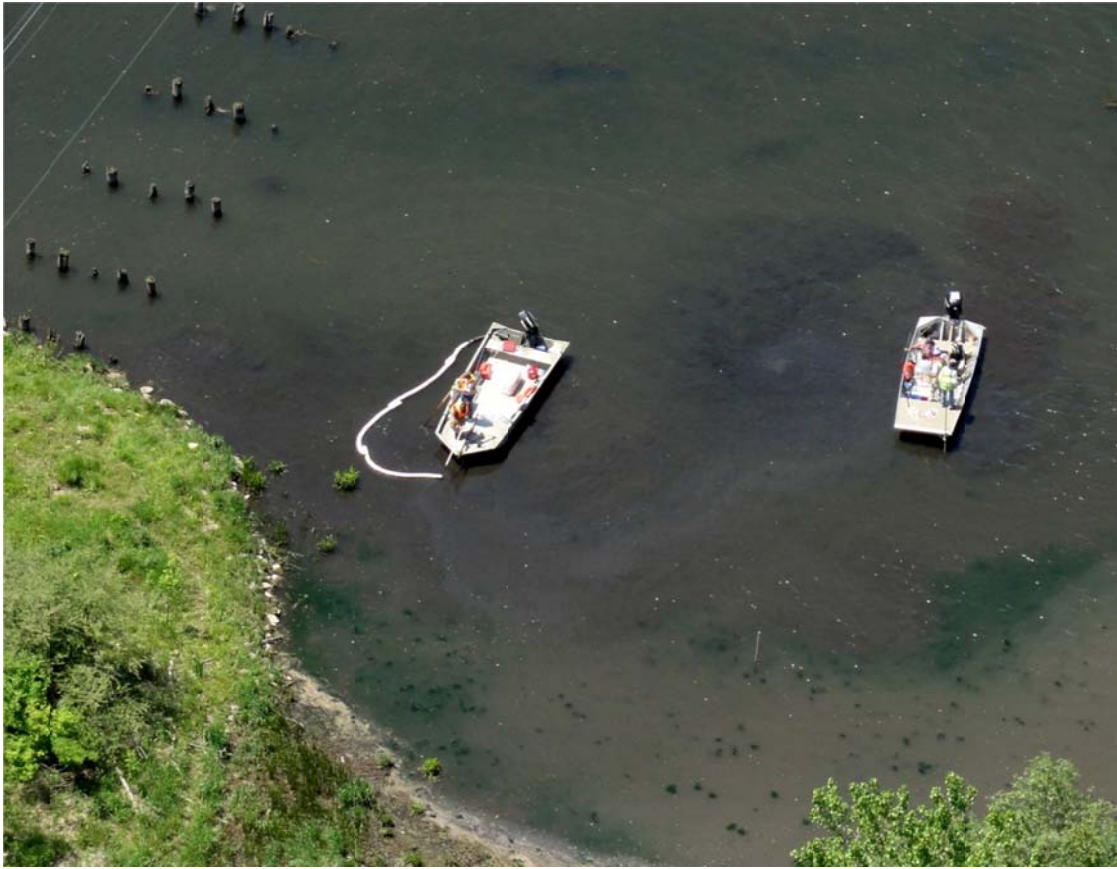
11. MP5.75 RDB sheen observed near sweeper boats.

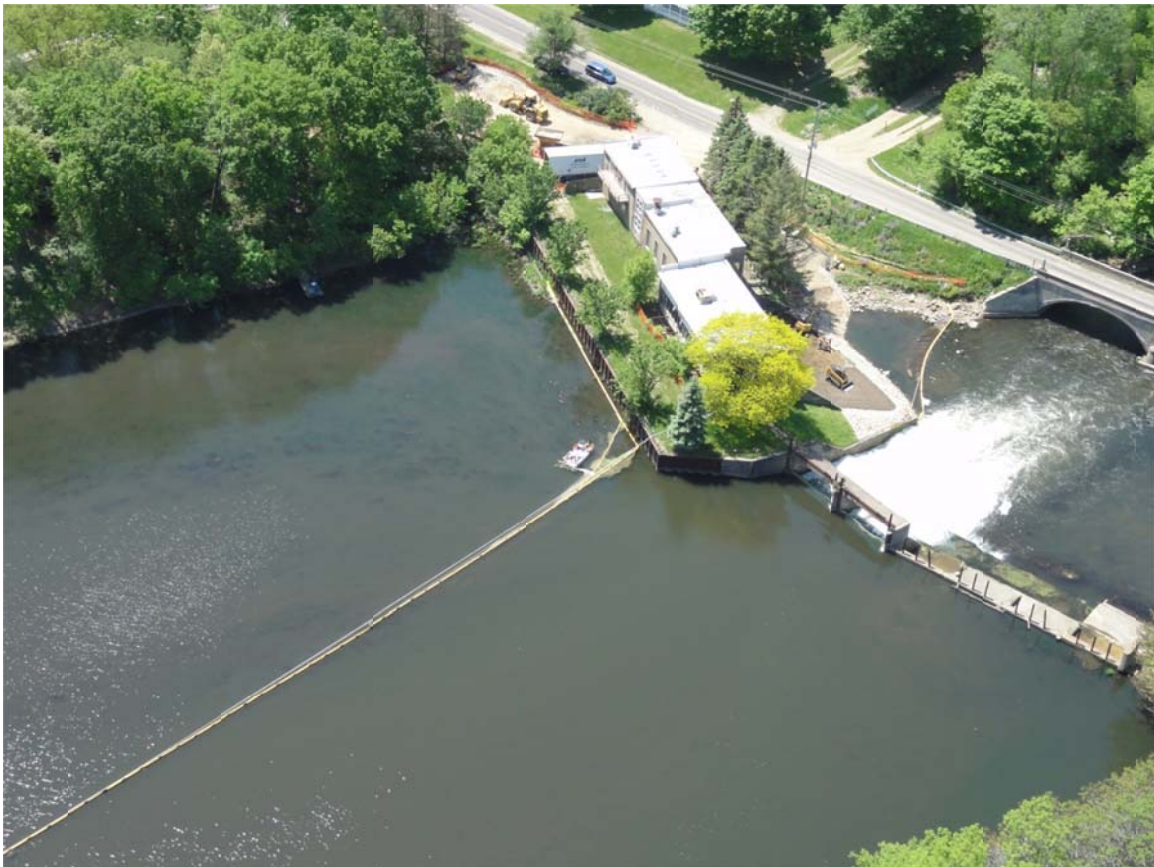
12. Ceresco Dam control point, no sheen observed.

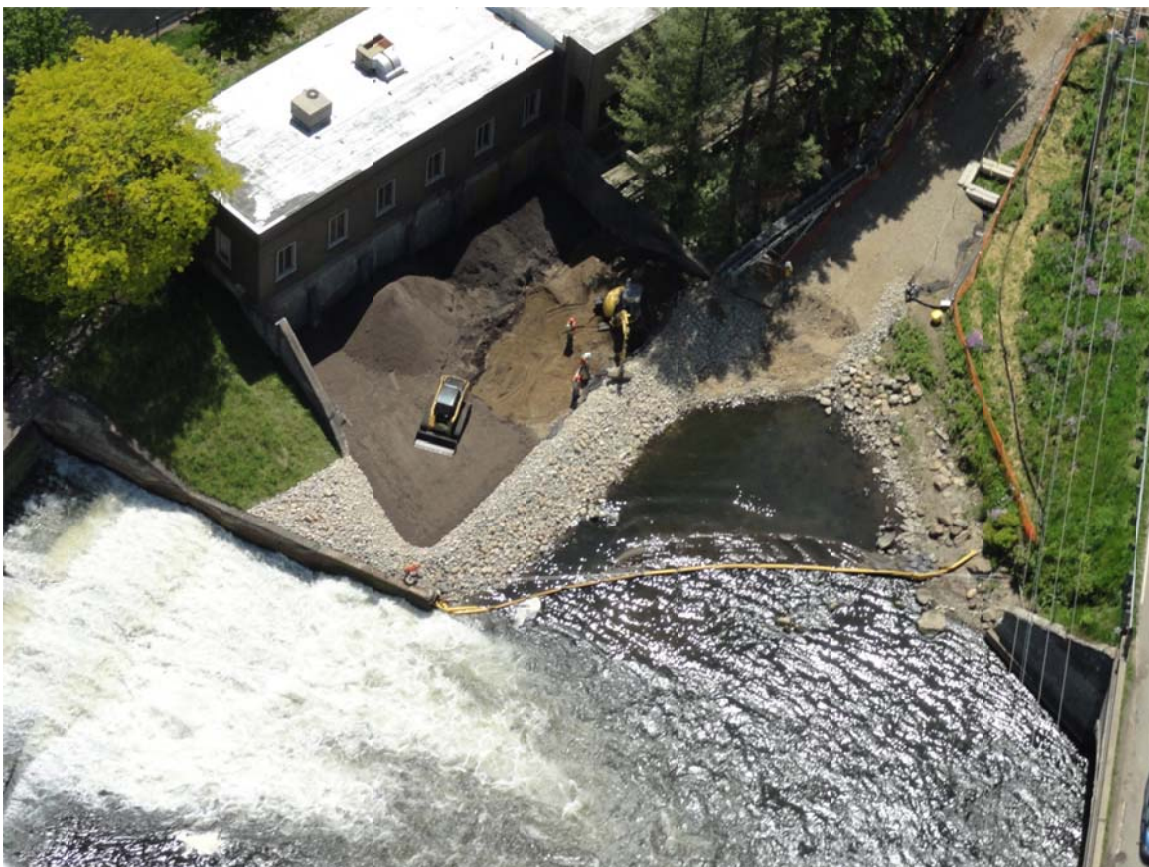
13. Ceresco Dam legacy work continued.

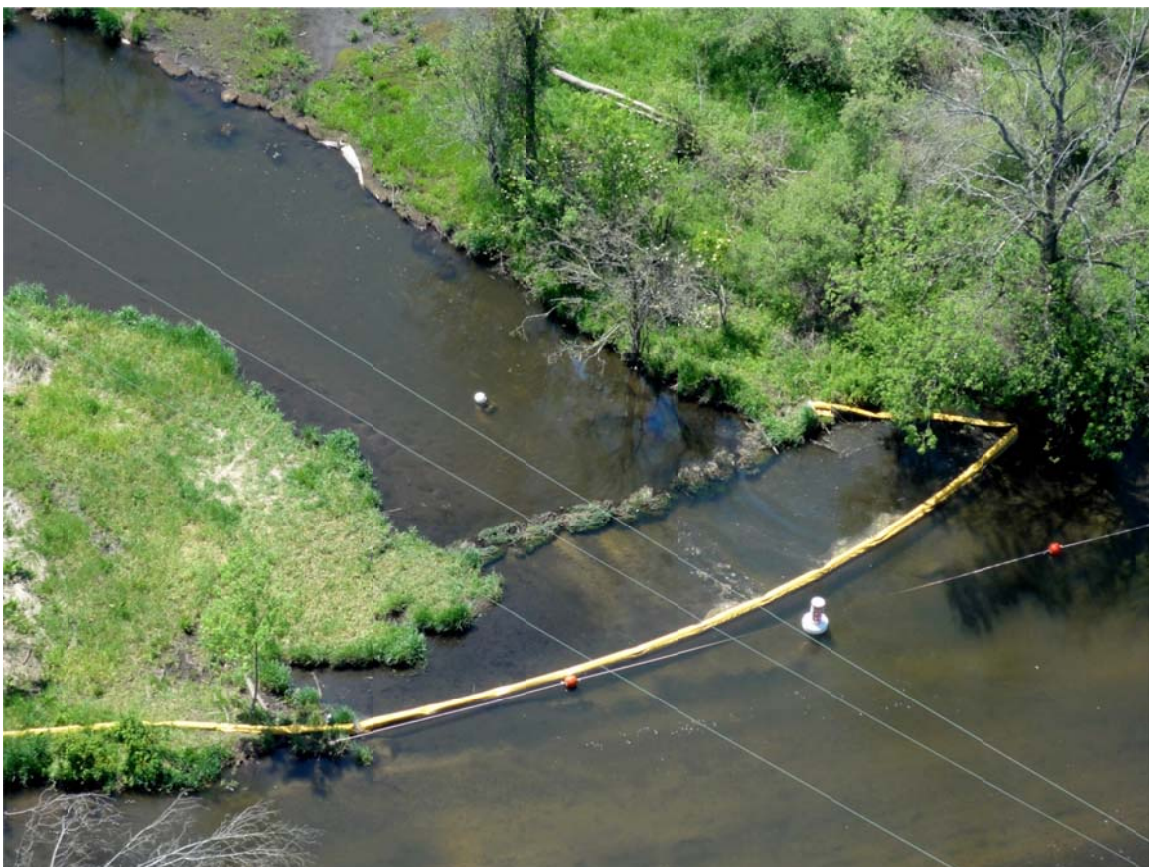
14. MP10.75 sediment trap location, sheen observed between sediment trap and containment boom.

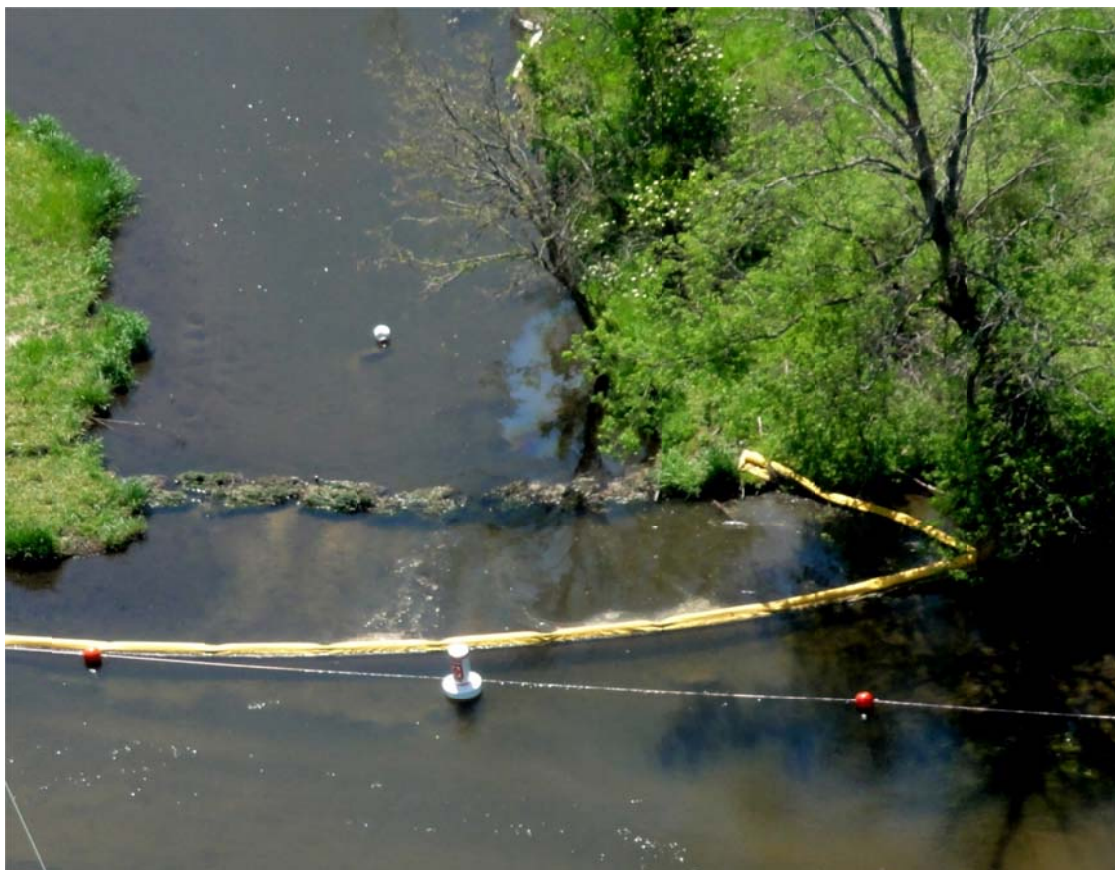
15. MP10.75 sheen at sediment trap location.

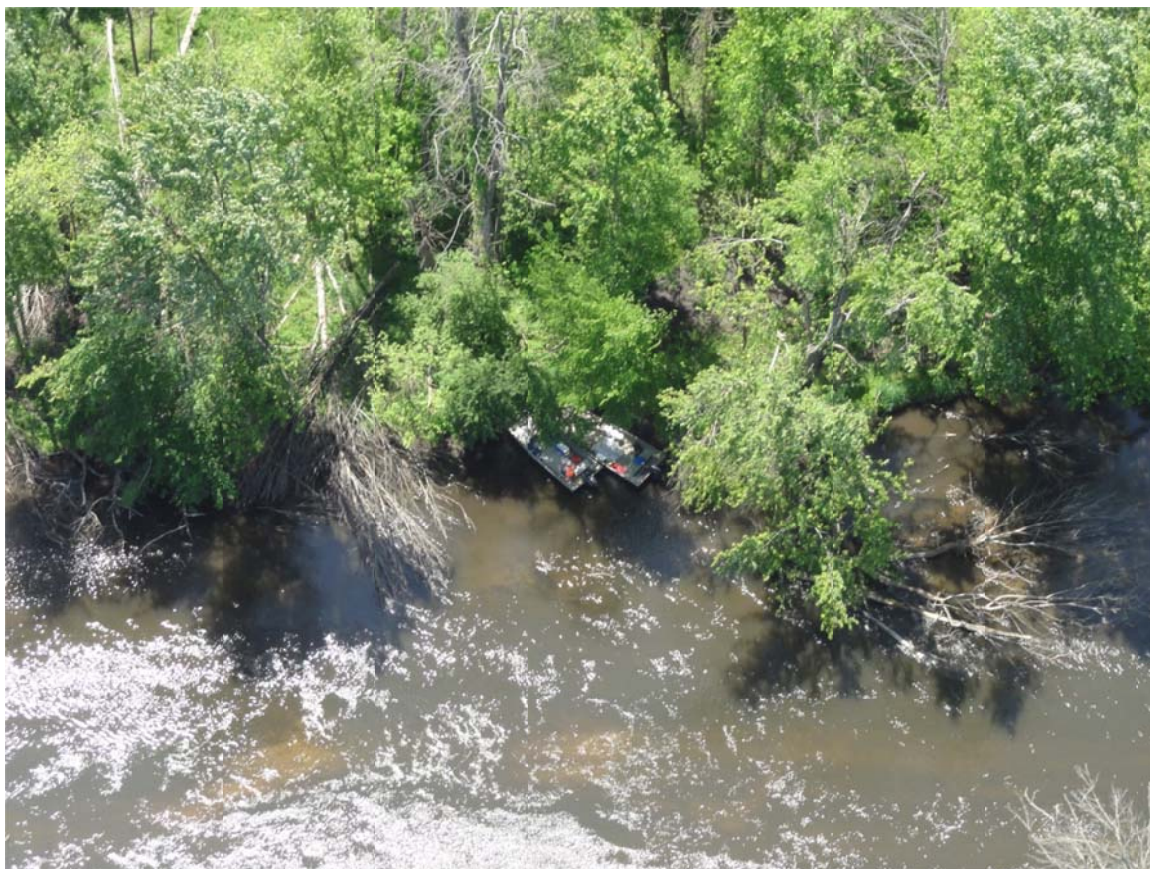
16. MP11.0, RI crews observed along LDB.

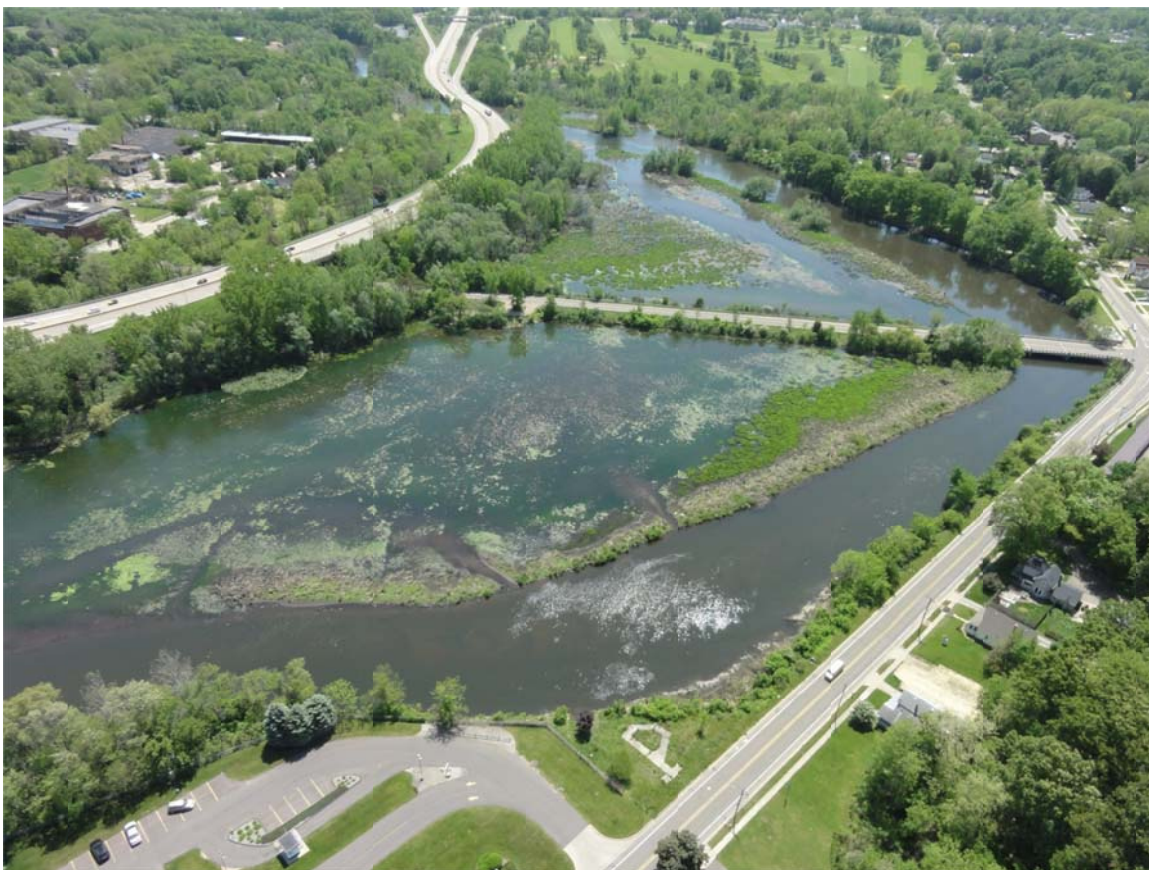
17. Mill Ponds, no sheen observed.

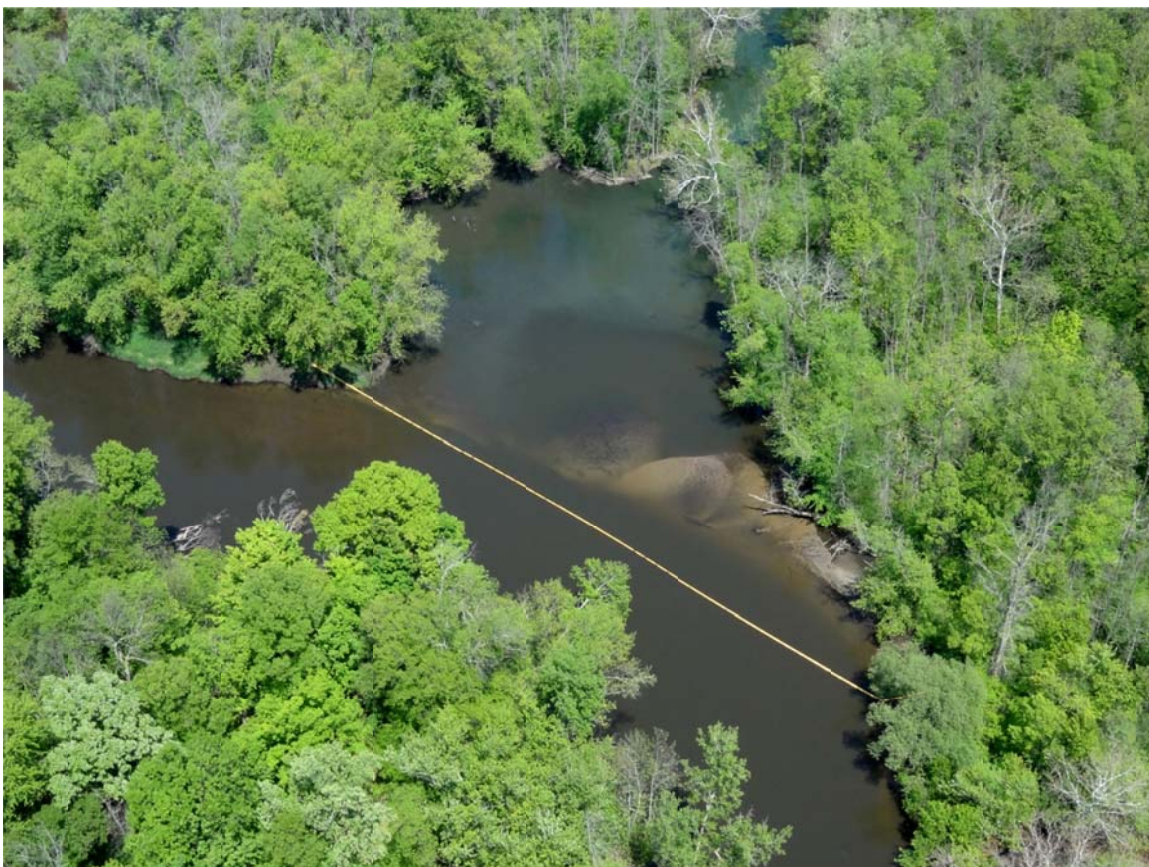
18. MP30.8, no sheen observed within newly installed boom.

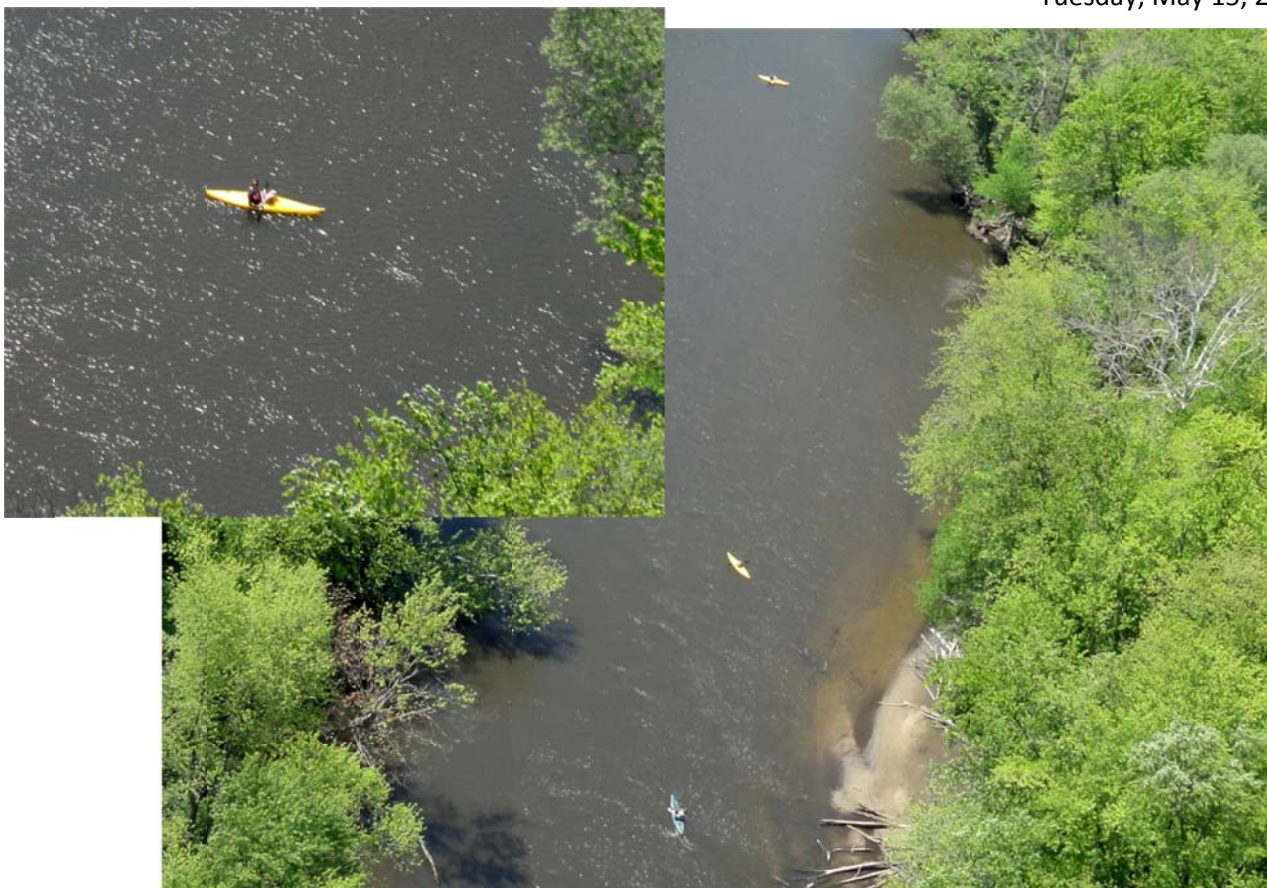
19. MP33.0, kayakers observed on river.

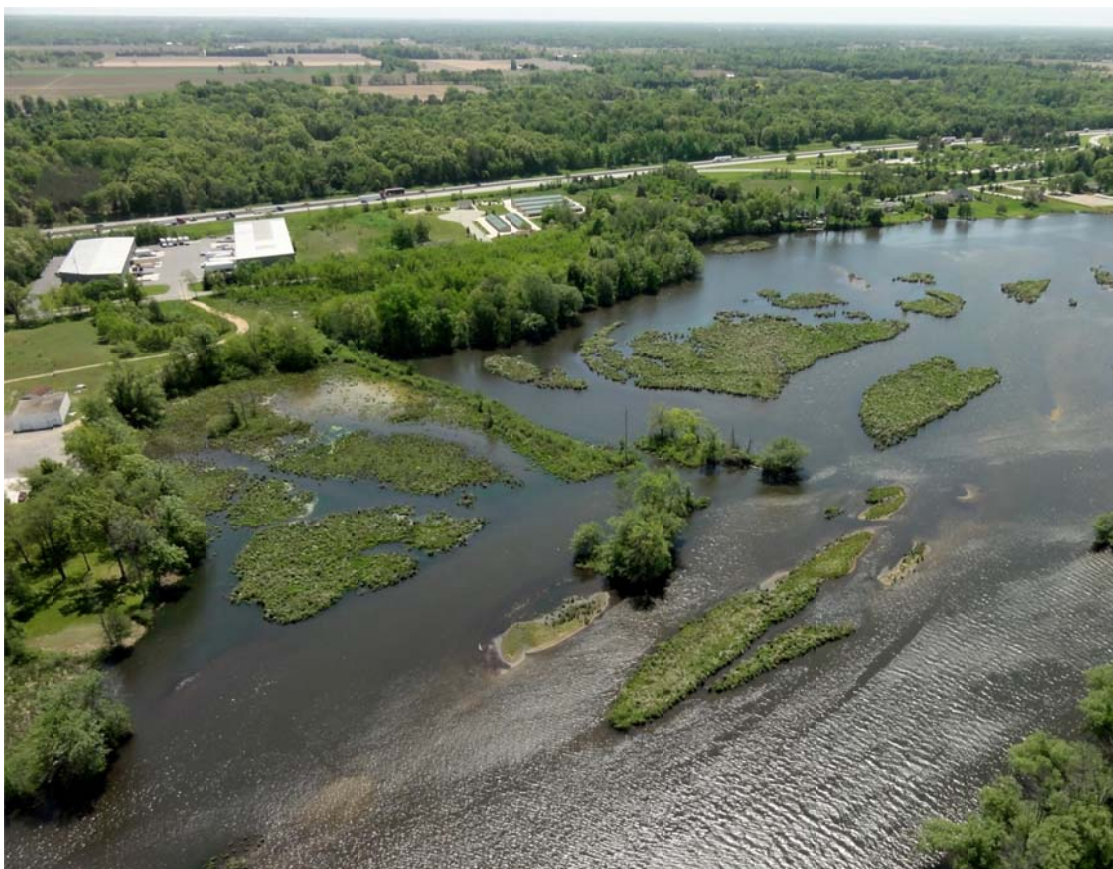
20. Morrow Lake Delta, no sheen observed.

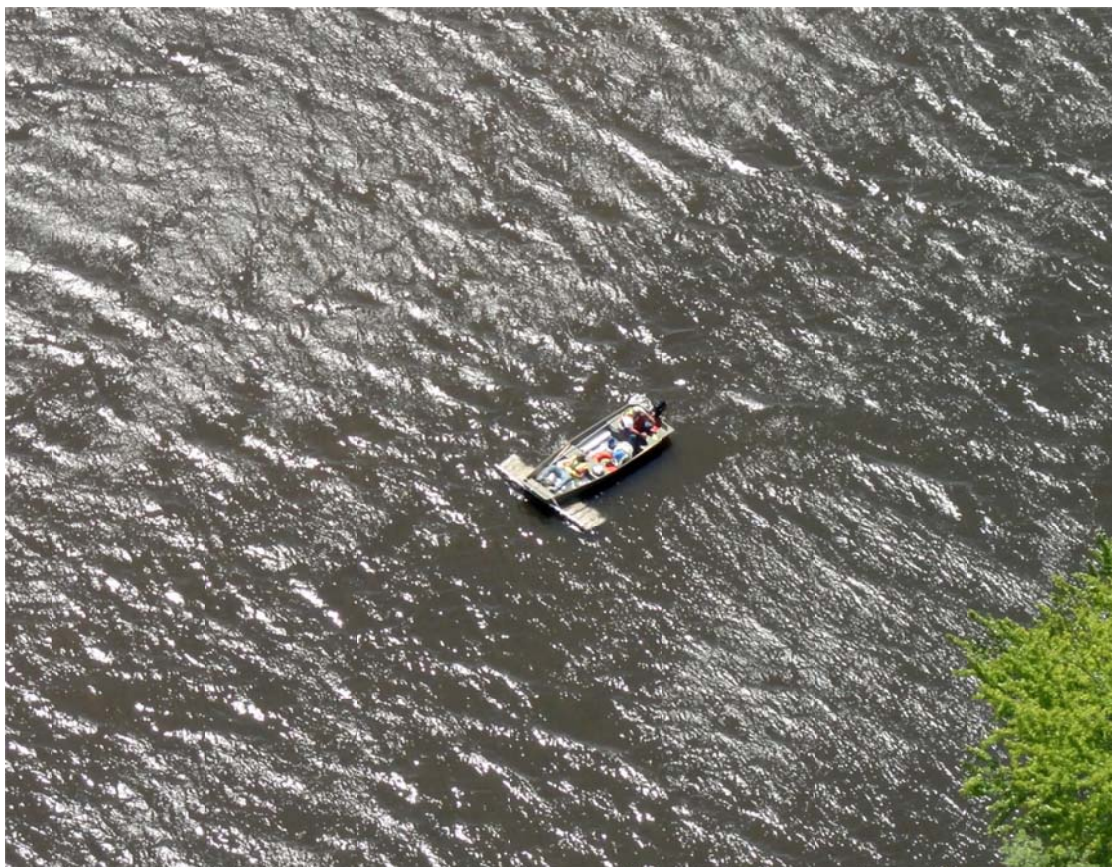
21. Sweeper boat on Morrow Lake Delta near Control Point E4.

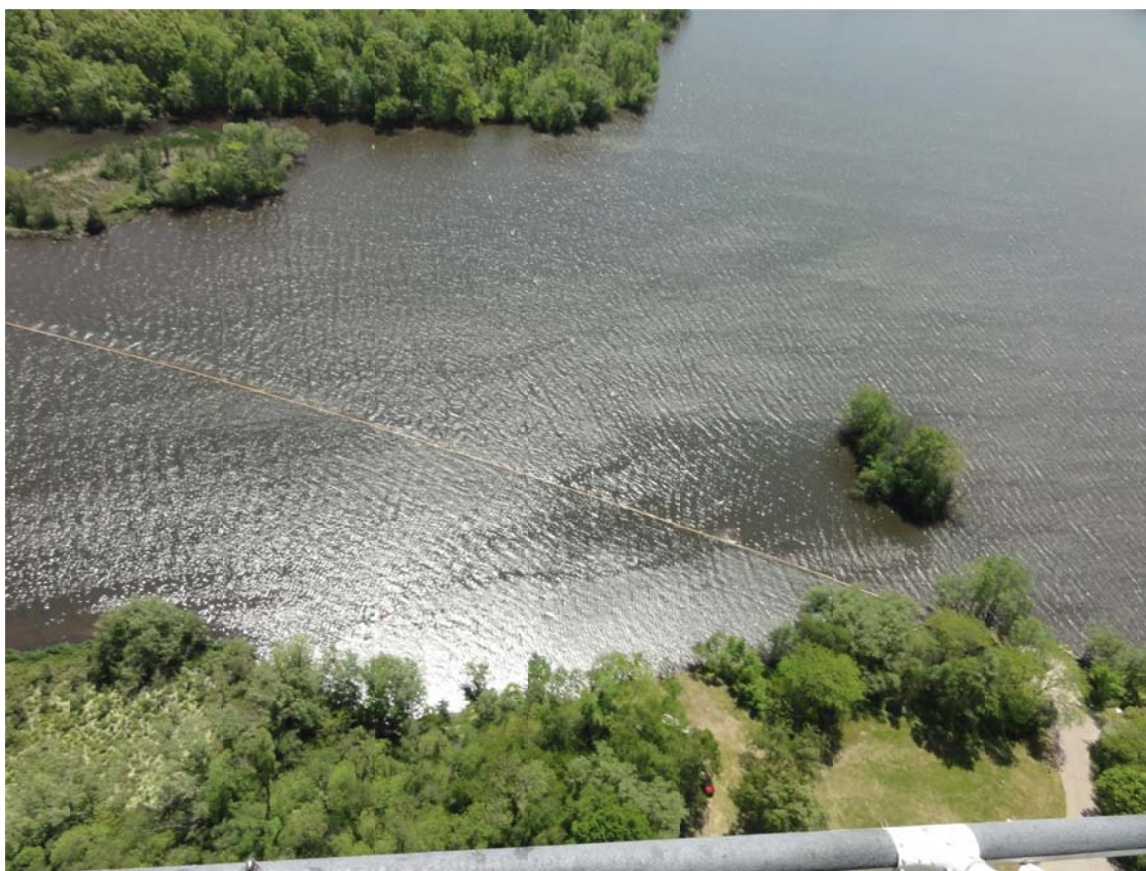
22. Control Point E4, no sheen observed.

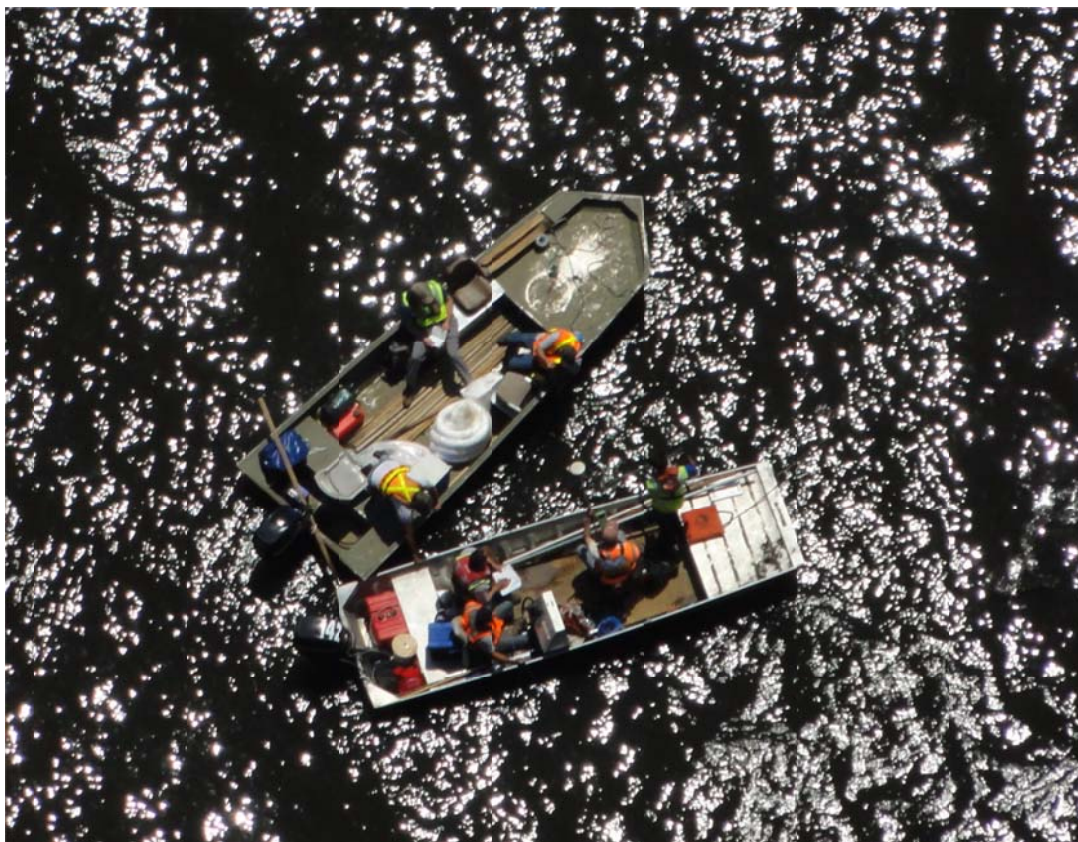
23. Poling crew on Morrow Lake along northern shore.
